Stress Corrosion Cracking of Ring Type Joint of Reactor Pipeline of a Hydrocracker Unit

P. Gore*, M. Sujata[#], S.K. Bhaumik[#]

[#]Council of Scientific and Industrial Research (CSIR), National Aerospace Laboratories, Materials Science Division, Bangalore 560 017, INDIA

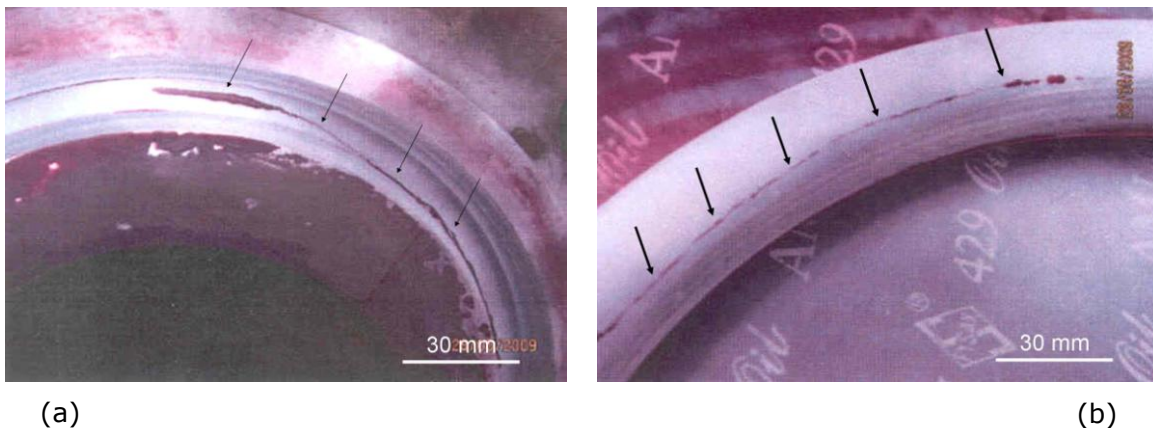
As a part of inspection during periodic shutdown, all flange joints of reactor pipelines of a hydrocracker unit were subjected to dye penetrant inspection (DPI). During this time, a crack was noticed in the groove of the flange of a RTJ. The crack was found present on the entire circumference of the groove (Fig.1(a)). DPI also revealed a circumferential crack over a sector of the ring gasket of the joint (Fig.1(b)).

Figure 1 Photographs showing cracks (arrows) on (a) groove of the flange, and (b) ring gasket after DPI

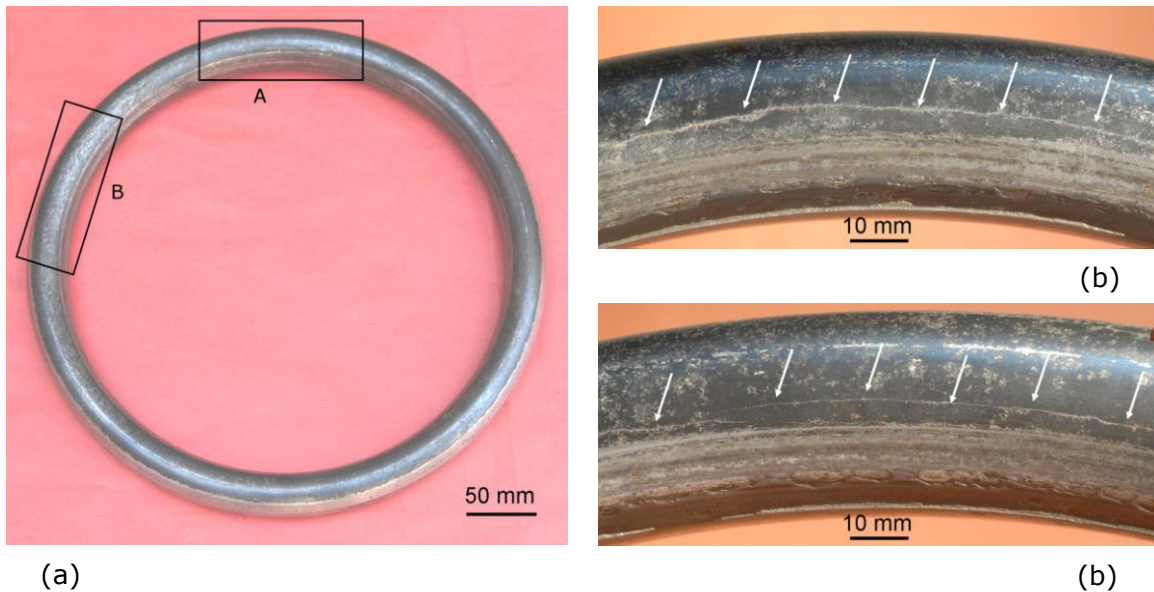
Figure 2(a) shows the ring gasket of the RTJ. Examination revealed that the ring had developed a number of discrete cracks. These cracks were located on the inner side of the ring and all of them were oriented in circumferential direction (Fig.2(b-c)). Figure 3(a) shows a sector of the flange received for investigation. Visual examination showed presence of a number of cracks located all over the groove of the flange (Fig.3(b-d)).

Figure 2 (a) Ring gasket, (b-c) close-up views of regions A and B respectively, marked in (a) showing cracks (arrows) in the circumferential direction

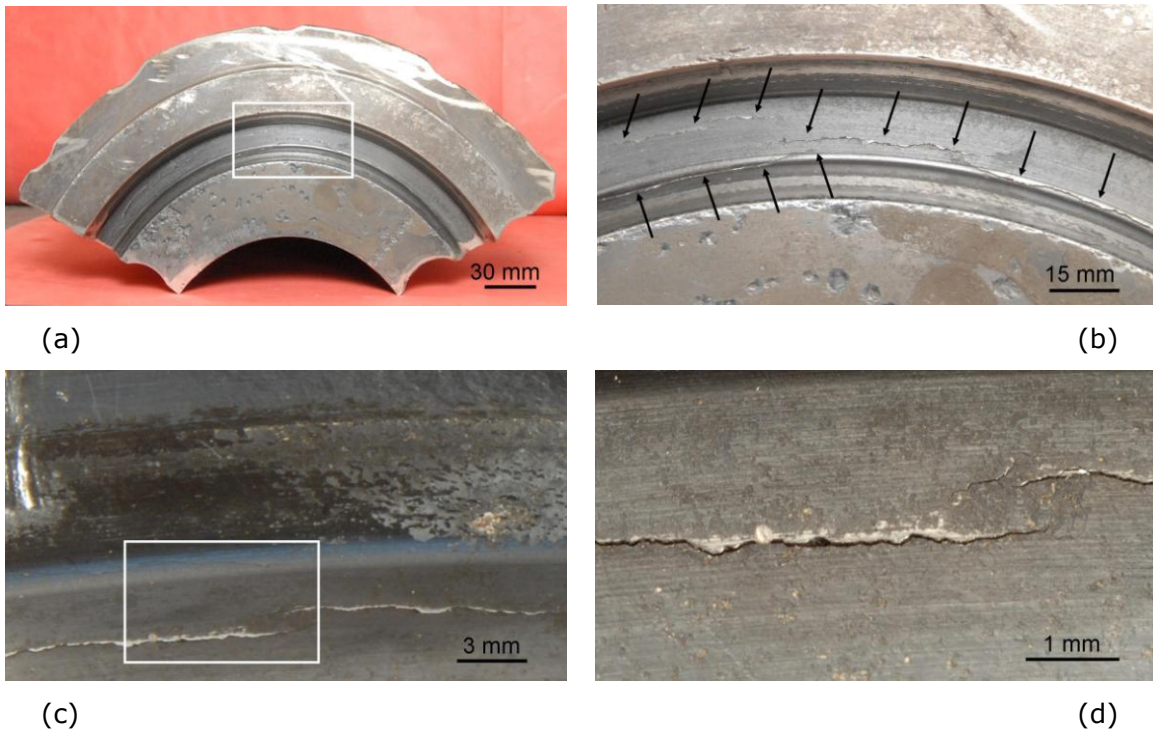
Figure 3 (a) a part of the flange of RTJ, (b) close-up view of the groove marked in (a) showing multiple cracks (arrows), (c) multiple cracks joining together, and (d) magnified view of the region marked in (c)

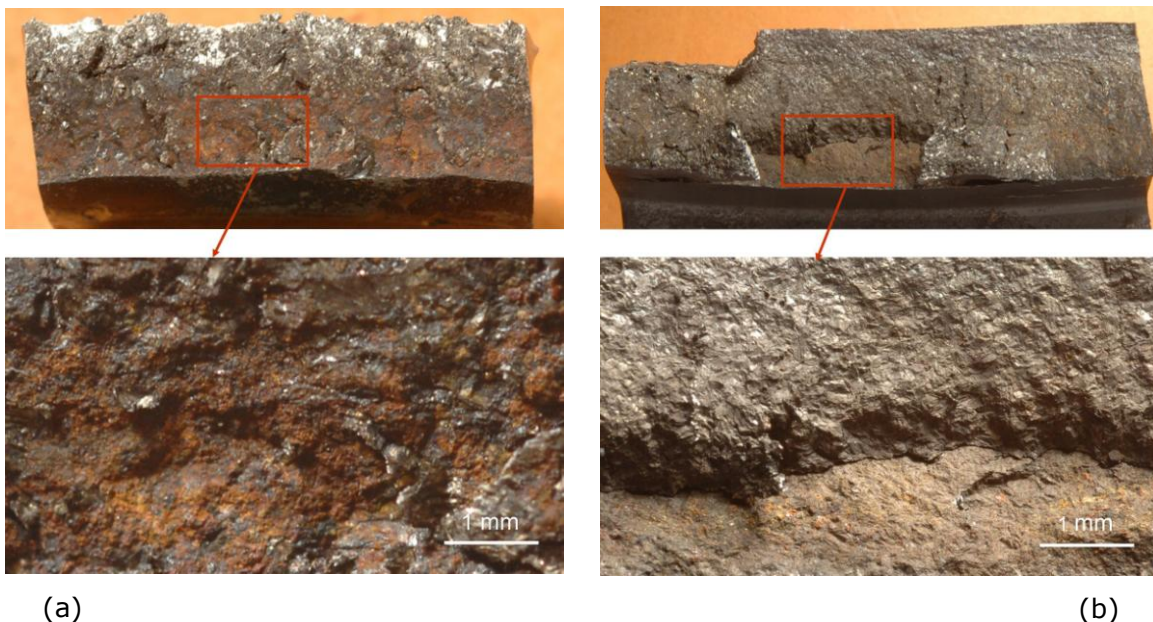
A few of the cracks from the ring gasket as well as the flange of the RTJ were pulled open by providing suitable cuts and the resulting fracture surfaces were examined under stereo-binocular microscope. The fracture surfaces were found covered with firmly adherent corrosion products (Fig.4).

Figure 4 Fracture surfaces of (a) ring gasket, and (b) flange of the RTJ showing presence of a thick layer of oxides and/or corrosion products

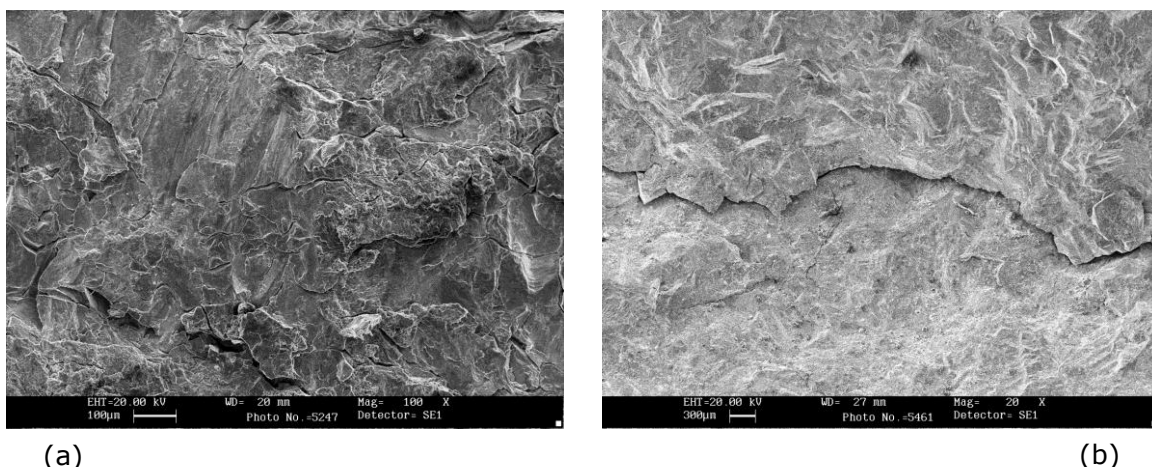
The crack surfaces shown in Fig.4 were cleaned ultrasonically in acetone and they were examined under a scanning electron microscope (SEM). Fracture surfaces were found covered with a thick layer of oxides and/or corrosion products and hence, the micro-fractographic features were largely obliterated. SEM examination, however, showed presence of large number of secondary cracks on the fracture surfaces (Fig.5). Compositional analysis

Figure 5 Scanning electron images of fracture surfaces of (a) ring gasket, and (b) flange of the RTJ showing obliteration of the micro-fractographic features due to corrosion

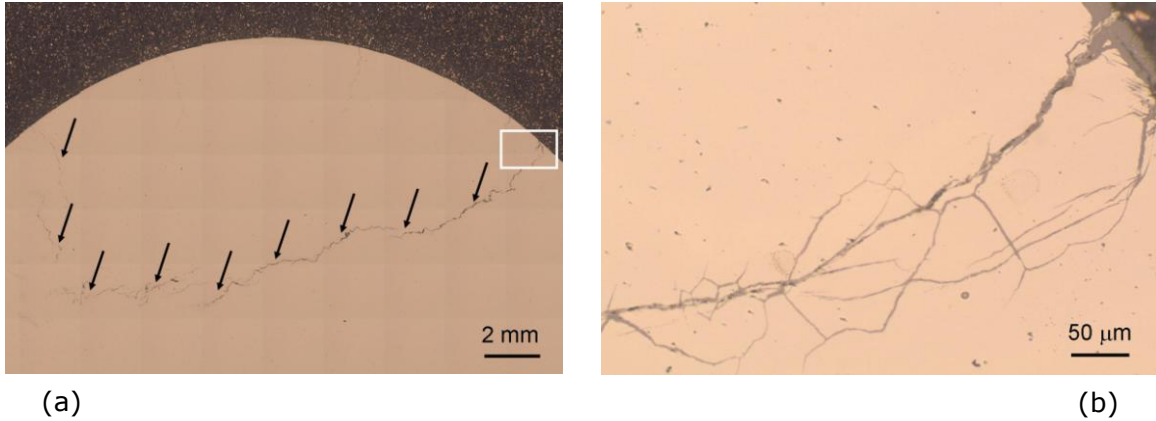
Figure 6(a) shows the profile of the crack propagation path on the cross section of the ring gasket. The crack appeared to have originated on the

surface, propagated progressively inside the material and finally, exited on the surface encompassing about one-fourth of the cross section. The magnified view of the crack near the surface is shown in Fig.6(b). Examination revealed multiple crack initiation at the surface and their propagation predominantly by transgranular mode, with extensive branching (Fig.7). Similar observations were made on the cracked flange as well, and these are summarized in Fig.8.

Figure 6 Cross section of the ring gasket showing (a) crack profile and propagation path, and (b) extensive crack branching

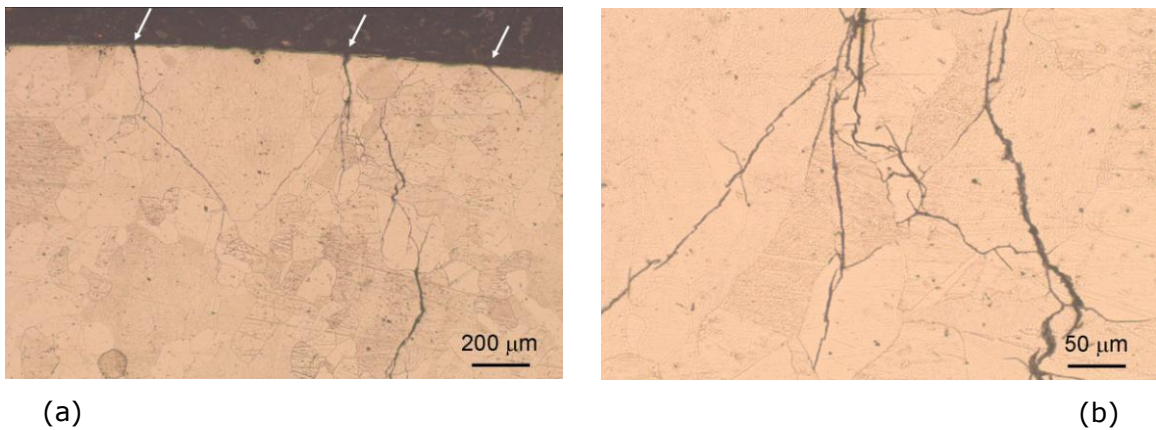
Figure 7 Etched microstructures showing transgranular mode of crack propagation in the ring gasket of the RTJ: (a) multiple crack initiation on the surface (arrows), and (b) inside the material

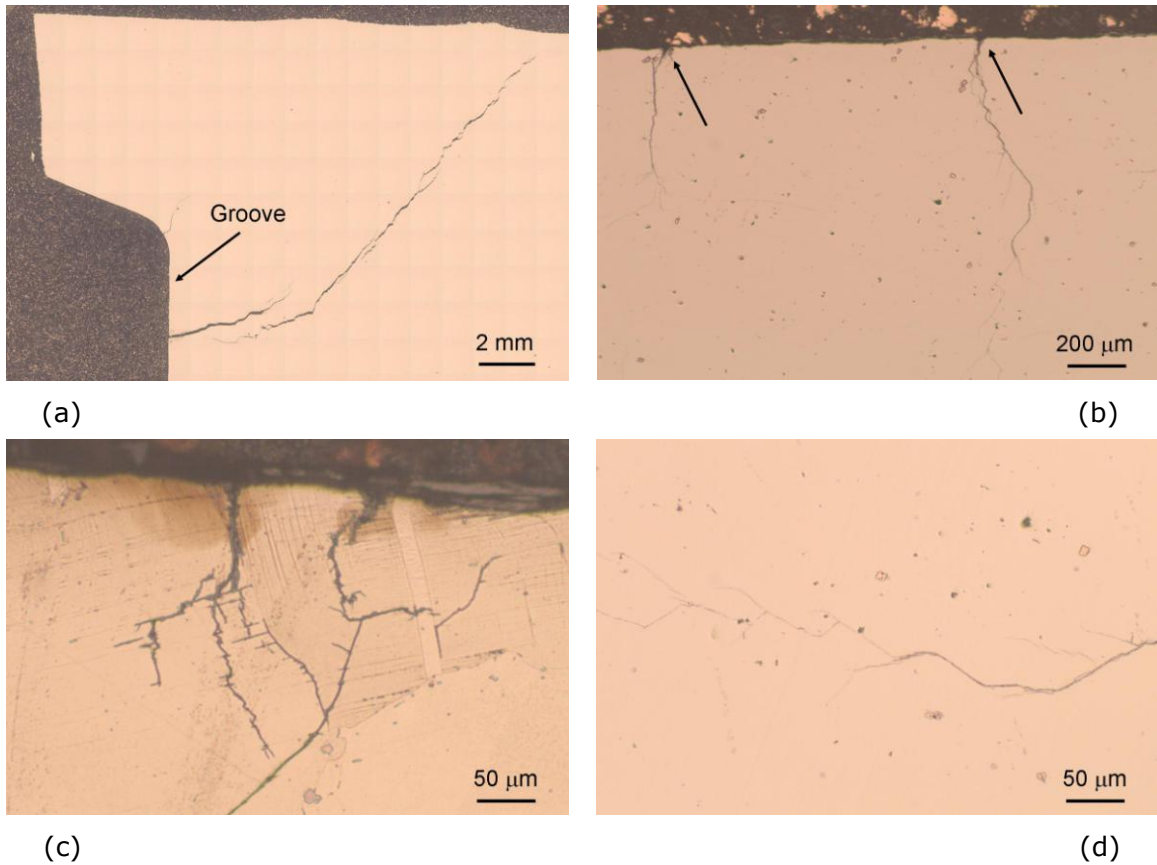
Figure 8 Crack initiation and propagation in the groove of the flange: (a) overall crack profile and crack propagation path, (b) multiple crack initiation on the surface (arrows), and (c) and (d) transgranular crack propagation near the surface and in the bulk material respectively

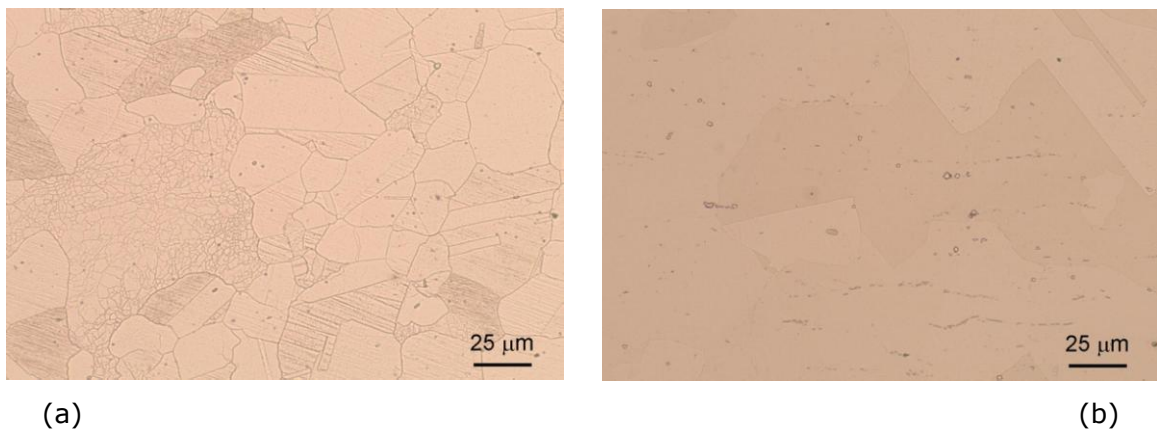
Figure 9 shows the microstructures of the ring gasket and flange material respectively. They were found to be consisted of twinned austenitic grains with uniformly distributed carbide particles. The materials were free from any metallurgical abnormalities such as sensitized structure.

Figure 9 Optical microstructure of (a) ring gasket, and (b) flange material consisting of austenite grains, with uniformly distributed carbide particles

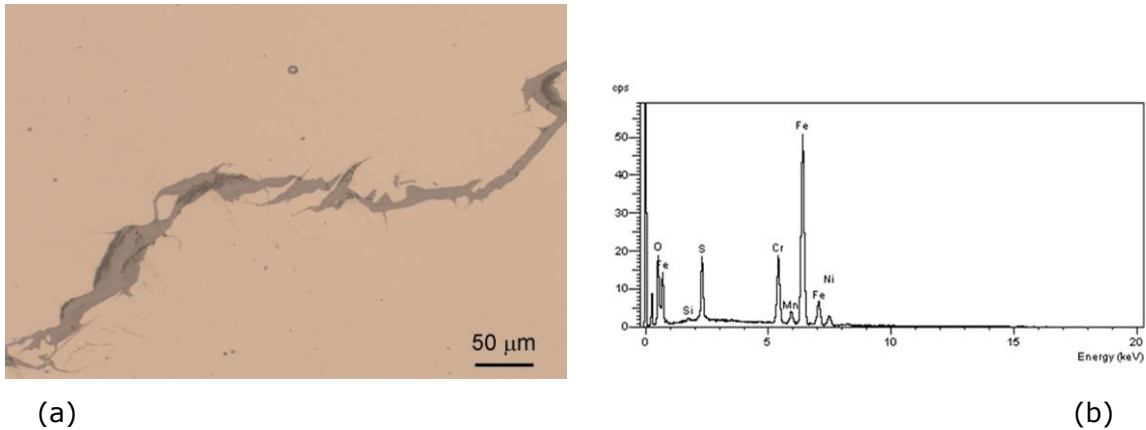
Figure 10(a) shows a propagating crack in the bulk material of the ring gasket. It can be seen that the crack is filled with corrosion products. EDX analysis showed that the corrosion products consisted of mainly oxides of iron and chromium, and sulphur in quantities as high as 5 wt% (Fig.10(b), Table 1). The cracks in the flange of the RTJ were also found filled with corrosion products of similar composition (Table 1).

Figure 10 (a) optical micrograph showing corrosion products within a propagating crack, and (b) EDX spectrum of the corrosion products
